**TYPE A ACCIDENT
INVESTIGATION BOARD REPORT
OF THE JULY 28, 1998
FATALITY AND MULTIPLE INJURIES
RESULTING FROM RELEASE OF
CARBON DIOXIDE
AT
BUILDING 648, TEST REACTOR AREA
IDAHO NATIONAL ENGINEERING AND ENVIRONMENTAL
LABORATORY**

September 1998

**Office of Oversight
Environment, Safety and Health
U.S. Department of Energy**

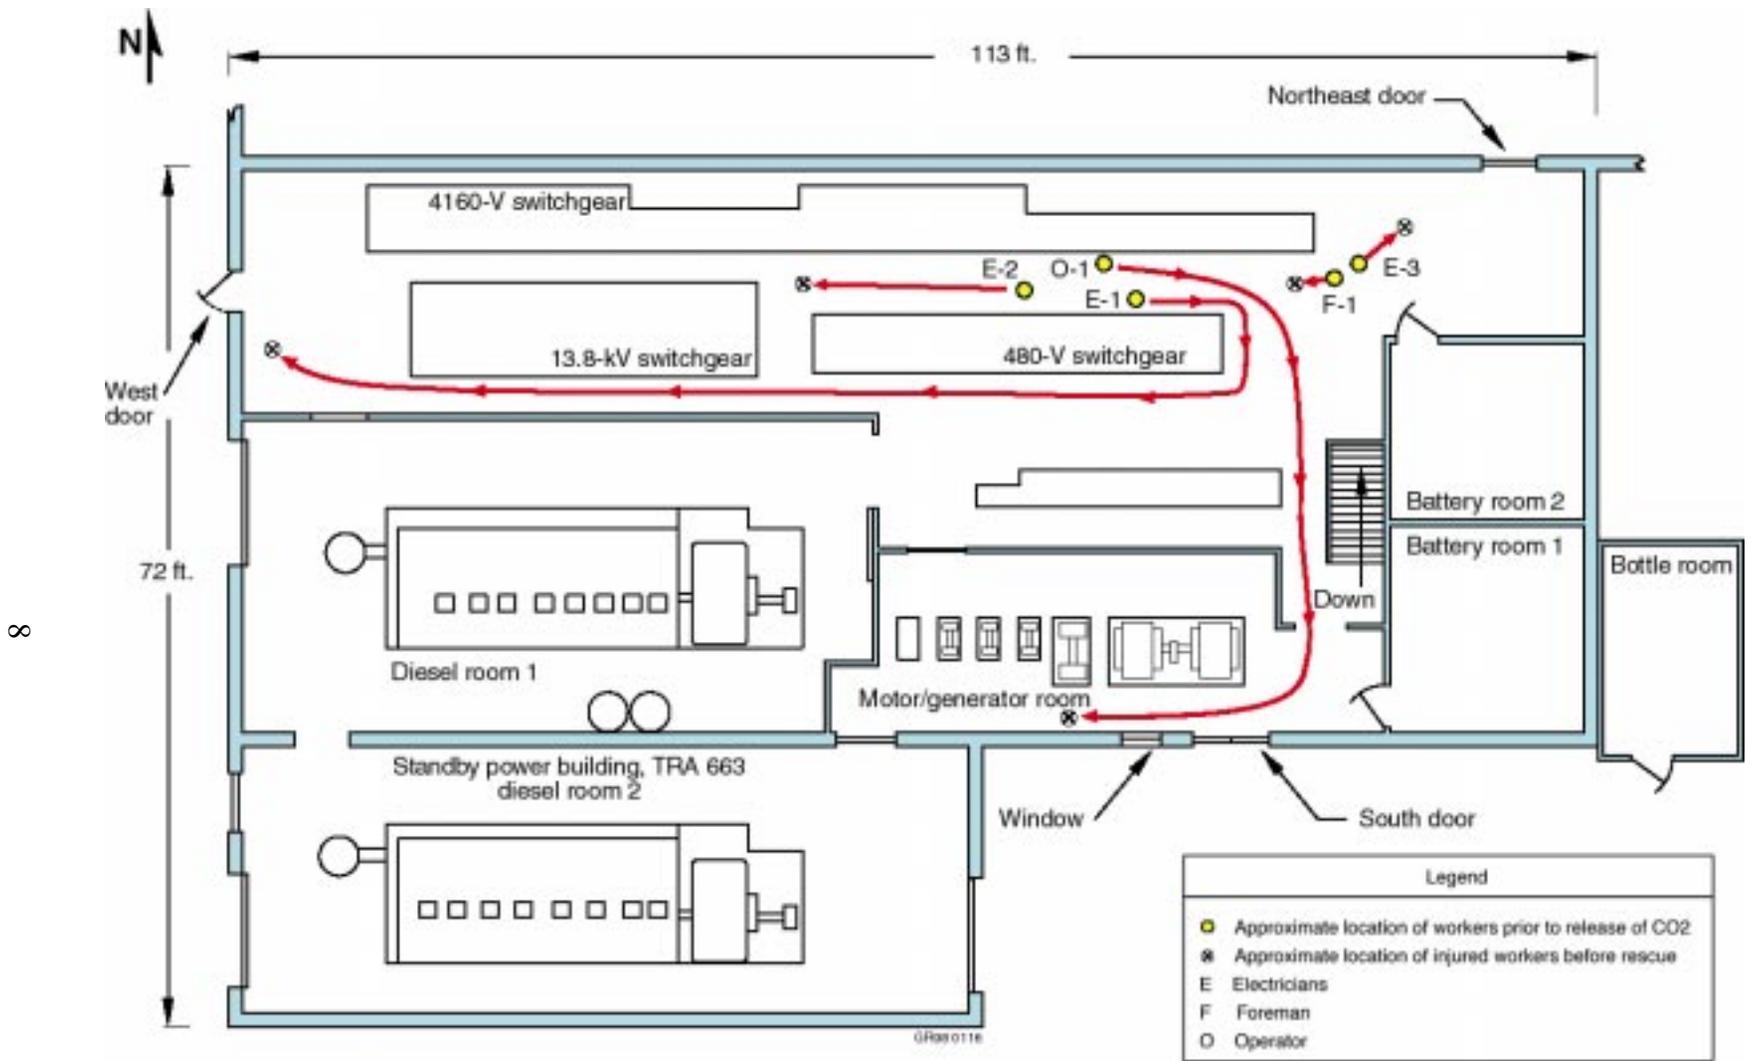
Exhibit 2-1. Building 648 Layout with Escape Routes of Five Injured Workers

One other individual (O-1) headed in a different direction, through the pump and motor generator room toward an exit door on the south side of the building (Exhibit 2-3). Unable to find the door in the whiteout conditions, he reached a window just past the door. In desperation, he put his hand through the thick glass window embedded with wire, sustaining severe arm lacerations and blood loss before losing consciousness (see Exhibit 2-4). Another individual (E-1) groped along switchgear, only to become entangled in an instrument cart and cable wires en route to the west door (Exhibit 2-5). He tripped, rolled, hit his head, and passed out inside the building.

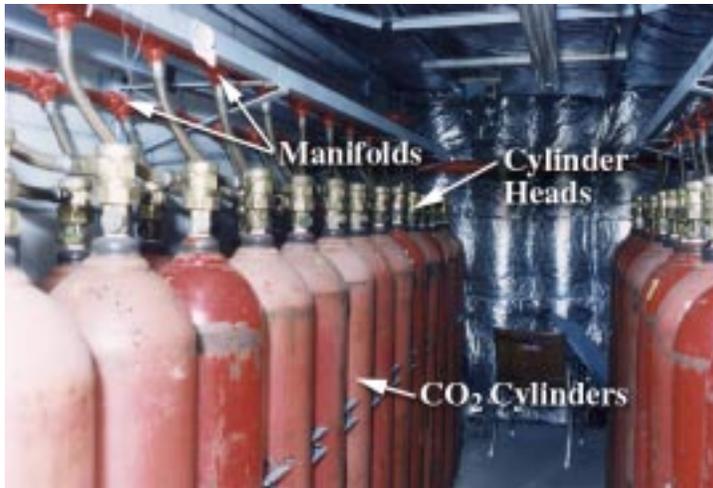
Exhibit 3-2. CO₂ Cylinders and Manifolds

together by manifolds, all of which are located in a CO₂ shed attached to the south side of the building (see Exhibit 3-2). The CO₂ manifolds connect to a system of piping and ceiling nozzles inside Building 648.

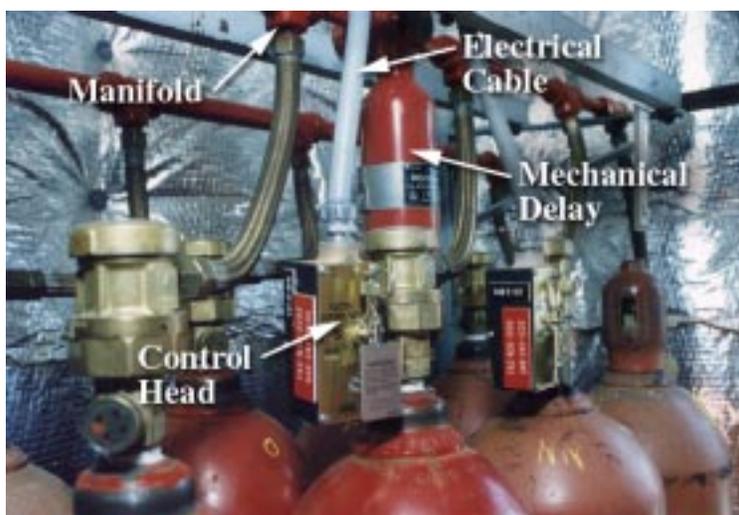
Exhibit 3-3. Control Head and Mechanical Delay Mechanism

- Recommending additional performance testing to further isolate facts regarding CO₂ system activation:
 - The removal of the 25-second mechanical delay from the CO₂ system header and bench testing to verify the length of the time delay. This test is pending.

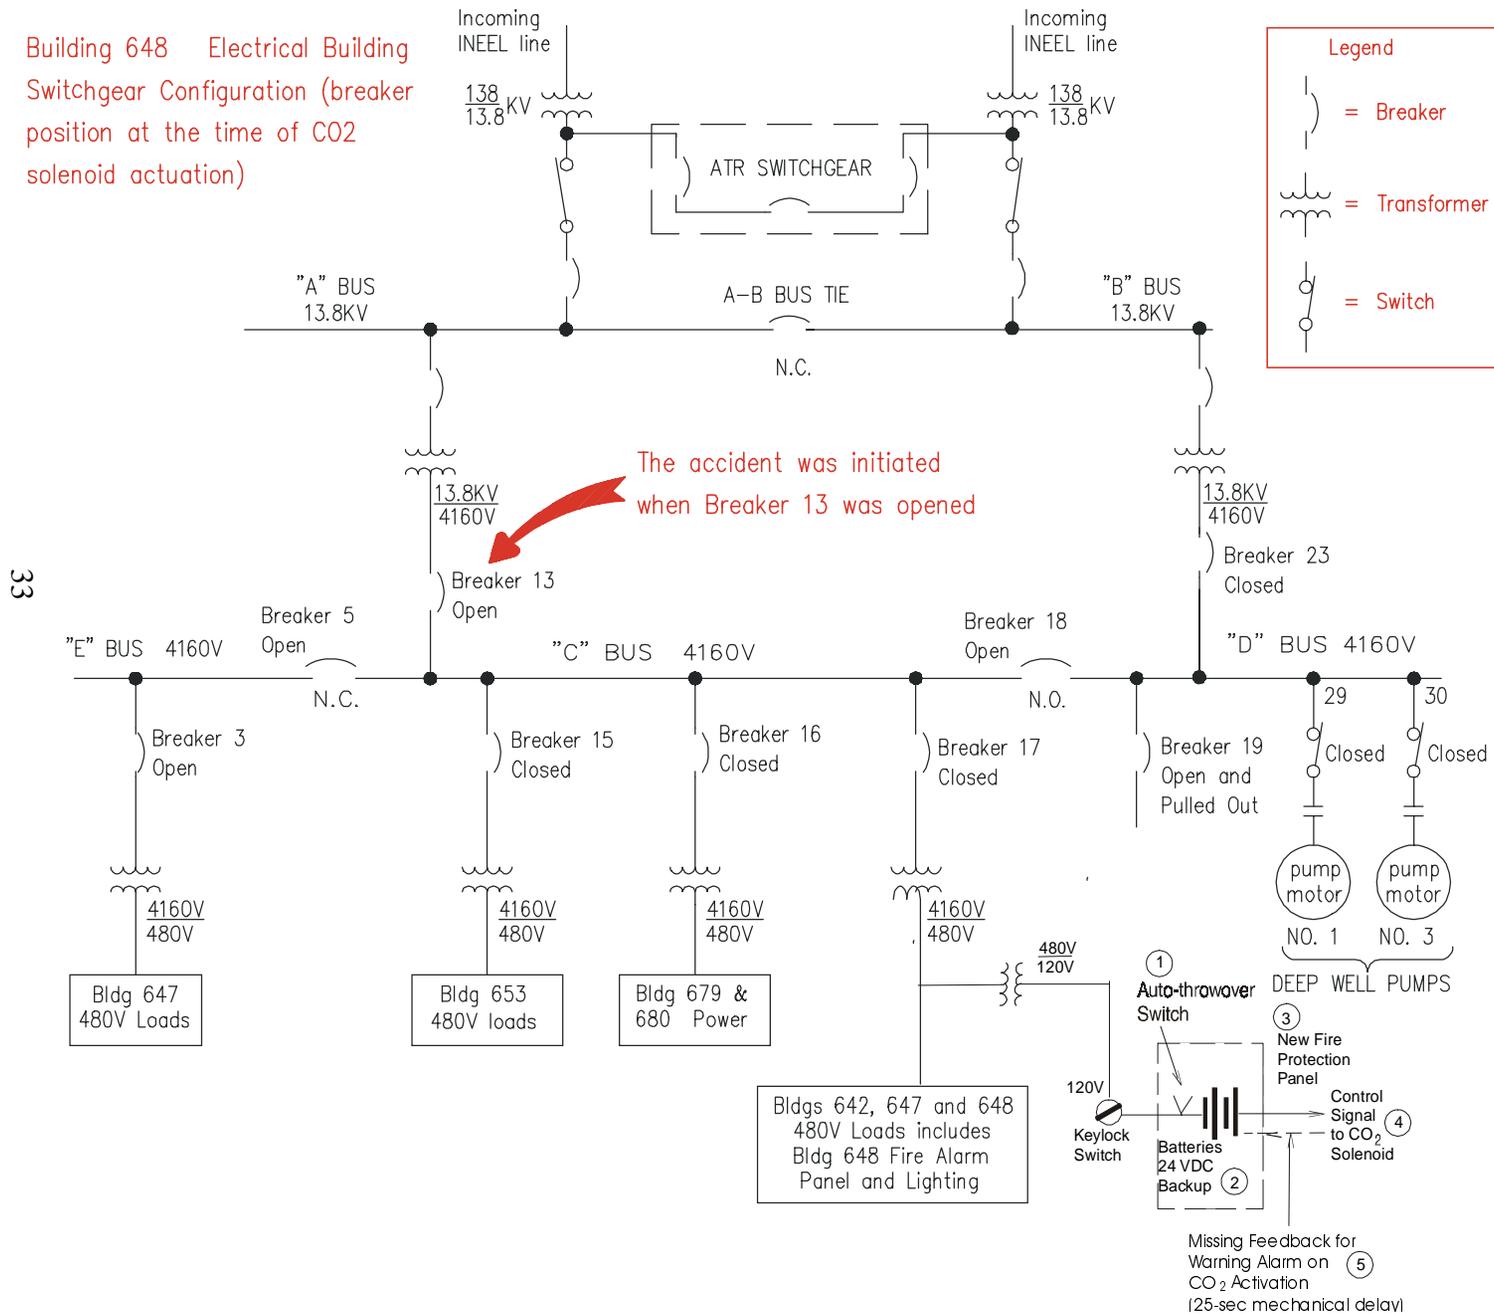
Figure 3-1. Simplified Schematic of Switchgear

Electrical power is provided to Building 648 by three sources: commercial power, diesel power, and batteries. Commercial power is provided from the main INEEL substation by two parallel 138,000 volt lines to the TRA substation, then from the TRA substation to Building 648 on two parallel 13,800 volt lines, and transformed to 4160 volts and fed on two parallel lines to the Building 648 switchgear. These parallel lines feed the 4160 volt bus through Circuit Breakers No. 13 and 23, with Breaker No. 18, which is normally opened, acting to tie together the 4160 bus sections. Breaker No. 13 feeds power to facilities through Breakers No. 15, 16, and 17. Breaker No. 23 feeds power to TRA deep well pumps. The diesel power supply to the Building 648 switchgear is not relevant to the accident. The battery power supply provides direct current (DC) voltage primarily used for switchgear control power at 125 volts DC. A simplified schematic of the relevant switchgear is shown in Figure 3-1.

Fire protection systems in Building 648, as well as building lighting systems, are fed electrical power from 4160 volt switchgear Breaker No. 17, that feeds a 480 volt switchgear Breaker No. 11C, and a 480 volt distribution panel (648-E-25). The fire protection system is fed from this distribution panel, through Lighting Panel K, to a 240 volt transformer, sub-panel KA circuit Breaker No. 5 which supplies 110 volt alternative current (AC) service to the Notifier AFP-200 panel. The fire alarm panel was provided with 60 hours of dedicated emergency battery backup power.

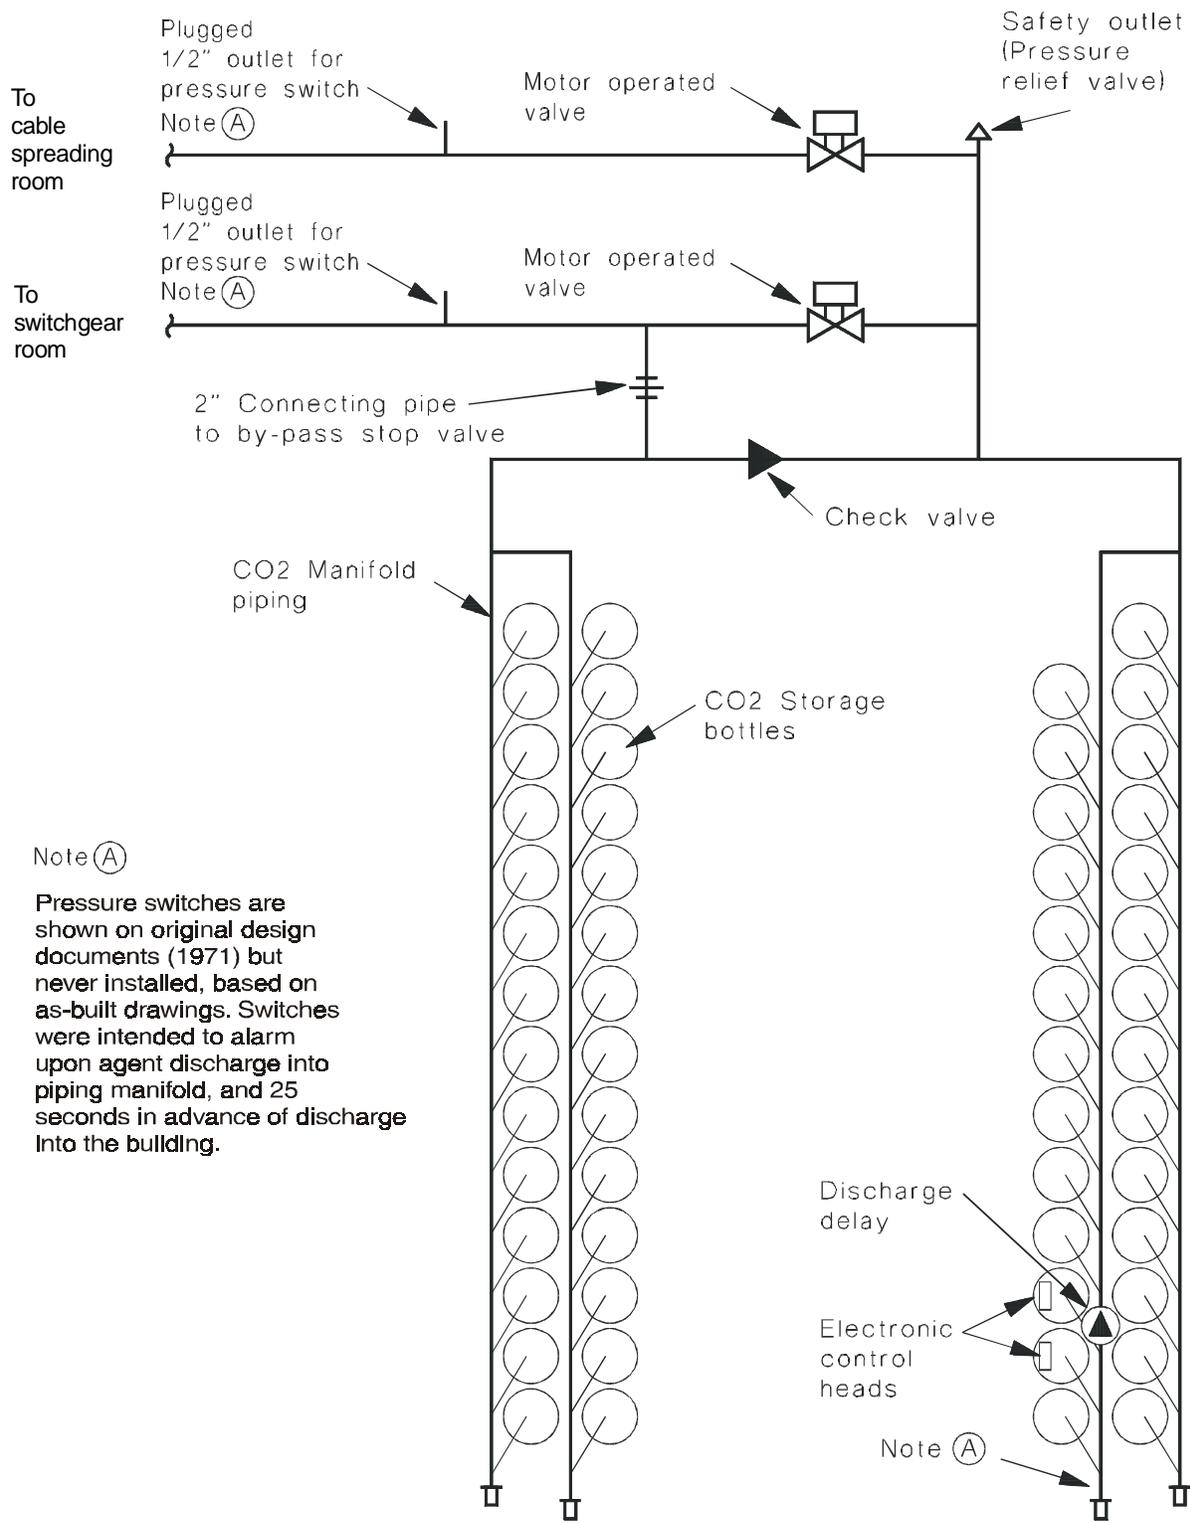
Figure 3-2. Carbon Dioxide System Arrangement Pre Line Item Upgrade

The failure to install a carbon dioxide system discharge monitoring circuit prevented a 25-second pre-discharge warning alarm and safe escape.

Note (A)
 Pressure switches are shown on original design documents (1971) but never installed, based on as-built drawings. Switches were intended to alarm upon agent discharge into piping manifold, and 25 seconds in advance of discharge into the building.

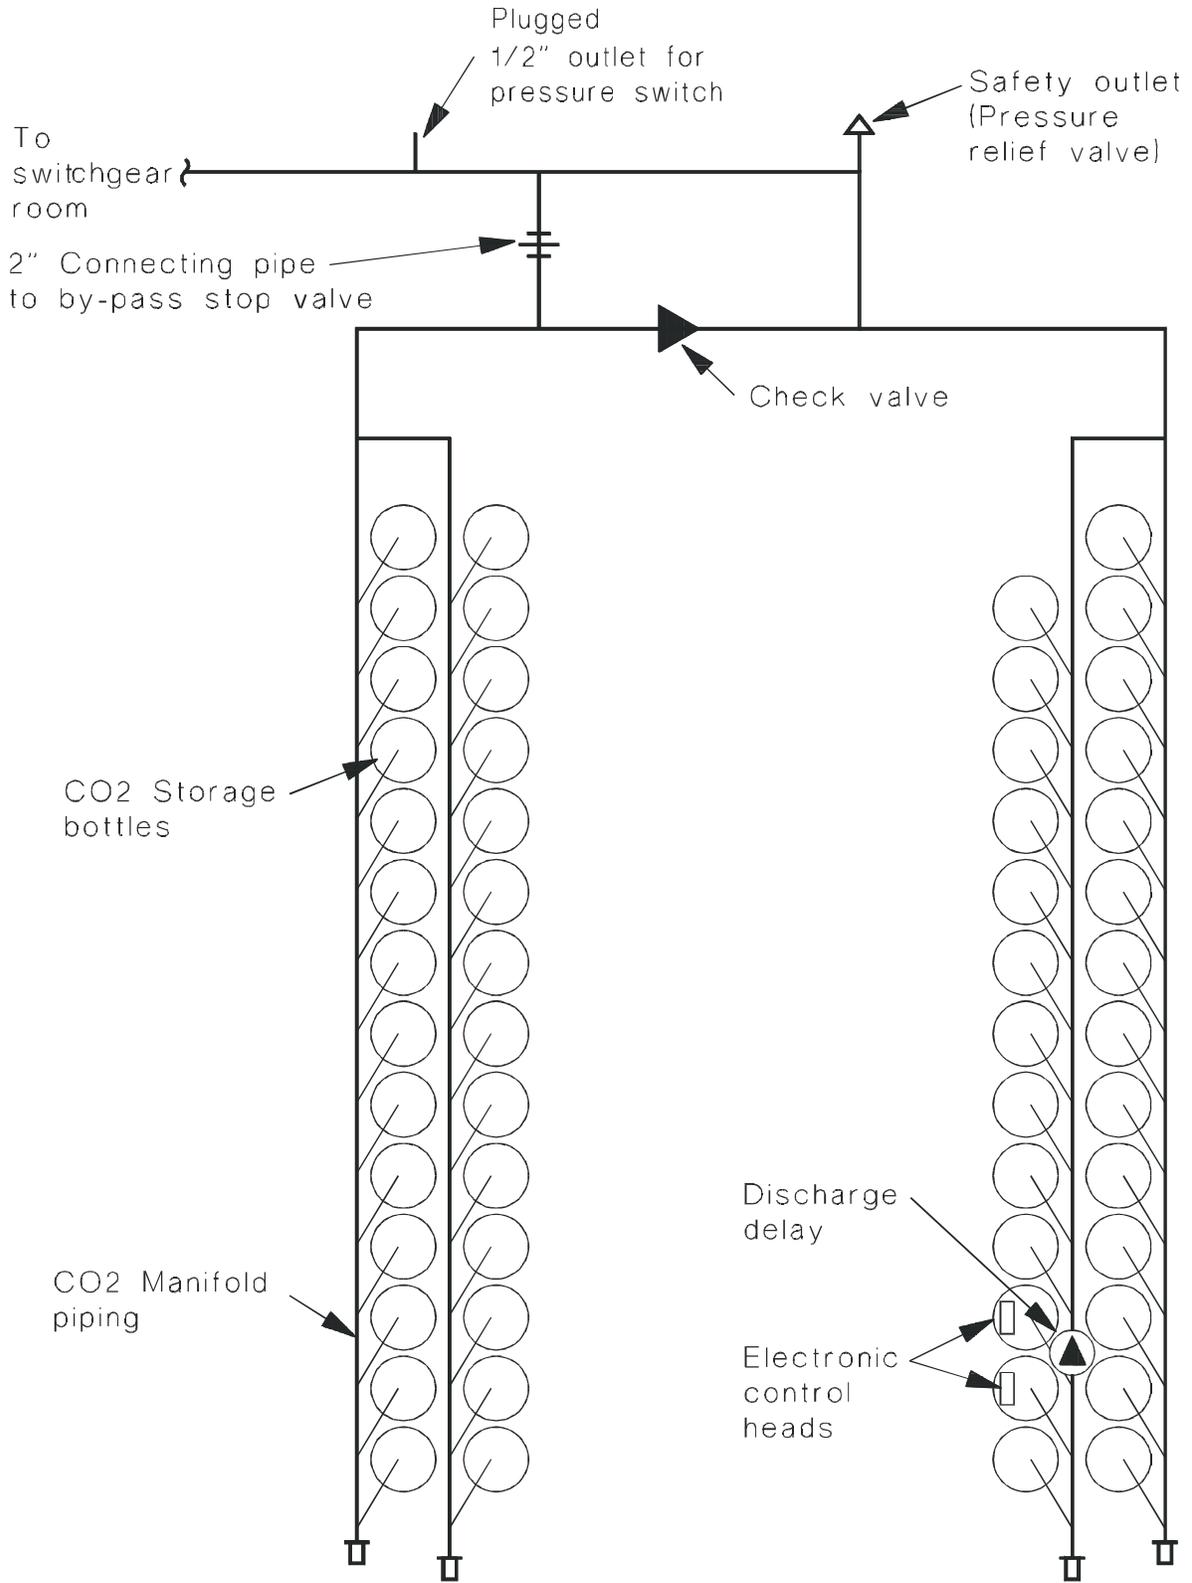
Figure 3-3. Carbon Dioxide System Arrangement Post Line Item Project

Deviations in the fire alarm system installation could have made it easier for a transient electrical input to trigger the unexpected discharge.

installation deviations were significant with respect to the accidental CO₂ discharge. The auxiliary power supply is suspect because opening Breaker No. 13 appears to have been the cause of the CO₂ discharge, presumably as a consequence of a voltage surge or spike. The fact that this power supply is unregulated and unfiltered may make it easier for a transient input to that supply to get through to the panel and trip the releasing circuits. The shielding on the addressable circuits is suspect because it is intended to dissipate transient signals before they can affect system operation.

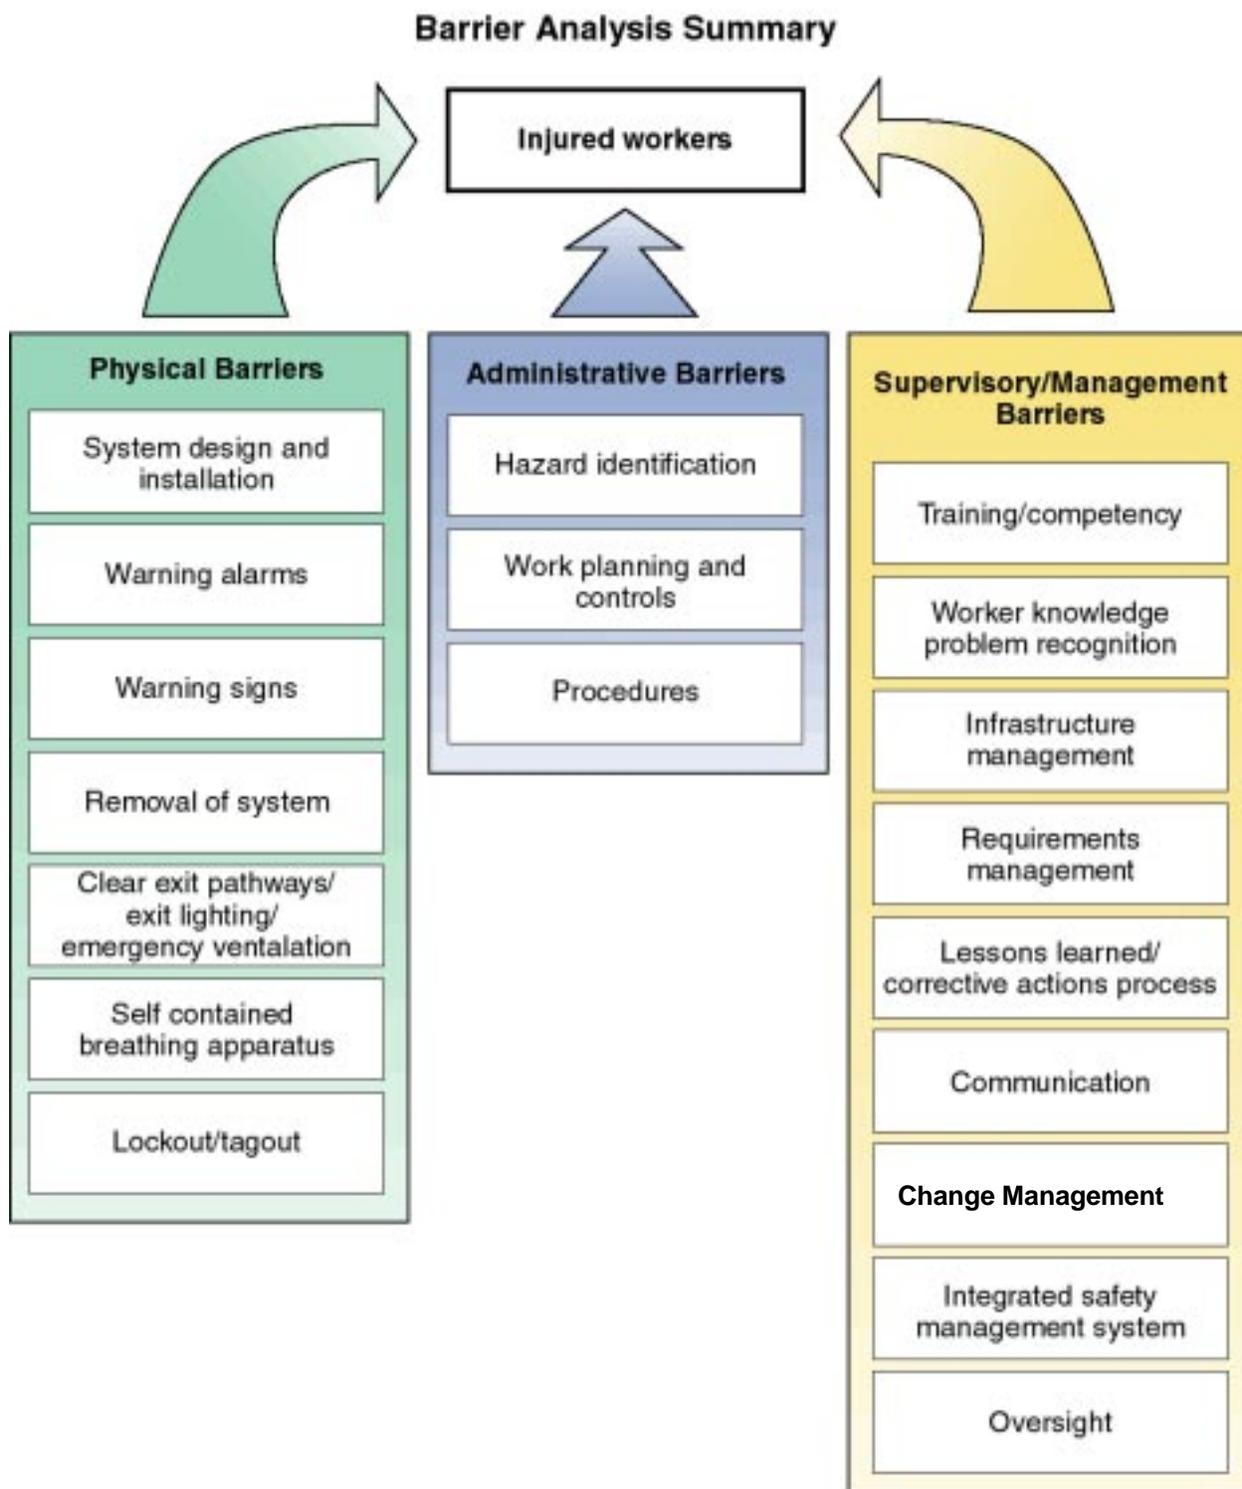
Figure 4-3. Barrier Analysis Summary

As seen on Figure 4-4, the lockout/tagout barrier had the capability to completely prevent the accidental CO₂ discharge and thus to eliminate the possibility of injuries and fatalities. The other physical barriers (e.g., CO₂ header pressure sensors and alarm feedback circuit, in conjunction with the 25-second mechanical discharge) would not have prevented the discharge but would have provided a pre-discharge alarm and time to escape the building if they had functioned properly, thus reducing the likelihood of injuries and fatalities. However, these systems were either not installed or failed.

A variety of barriers related to emergency preparedness could have facilitated emergency escape and immediate search and rescue, thus reducing the risk to rescuers and possibly avoiding serious injuries. However, as discussed previously, weaknesses were evident in many of these barriers, so accident mitigation was not totally effective, and the accident's consequences were not minimized.
